Technical Notes

Enhancing the 750/760 Transfer Scheme for Incomer and Tie Breaker

GE Publication No. GET-8387A

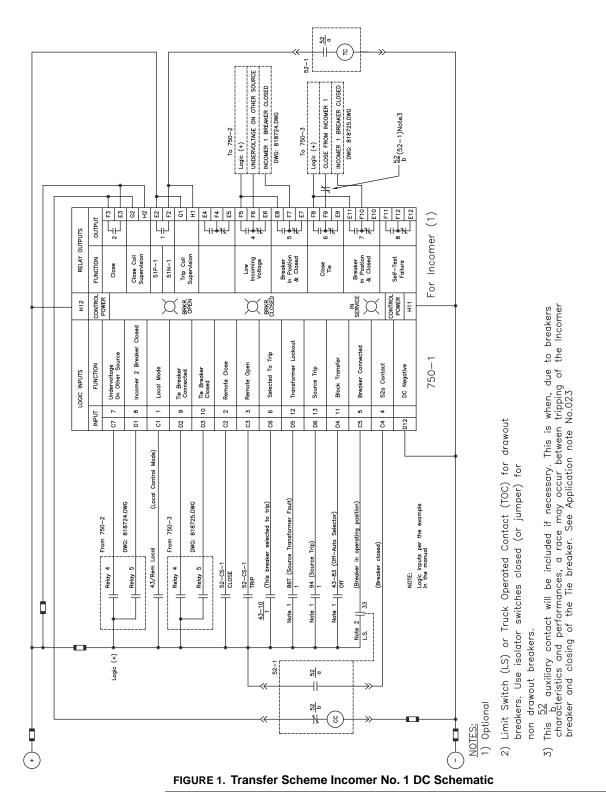
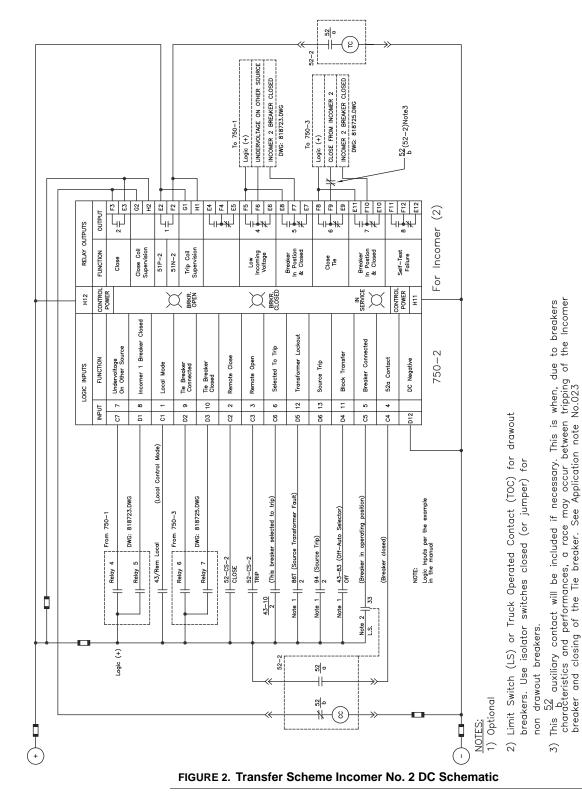
In some situations the tie breaker, if "selected to trip", will trip shortly after it has been closed by the transfer scheme. This may happen either because the tie breaker closing time is short compared to the incomer breaker trip time, or because the incomer breaker's auxiliary contacts are slow.

The problem can be solved connecting an auxiliary contact type 52/b in series with the output contact from Auxiliary Relay No. 6 in Figures 1 and 2 below. In this way the close command will be sent to the tie breaker only after the incomer from the lost source has tripped. The output type of Auxiliary Relay No. 6 must be set as "Pulse" and the pulse dwell time must be long enough to ensure correct operation of the scheme (longer than the incomer breaker trip time).
