# Firmware Upgrade Procedure for the L90 Line Differential Relay

GE Publication Number: GET-8471

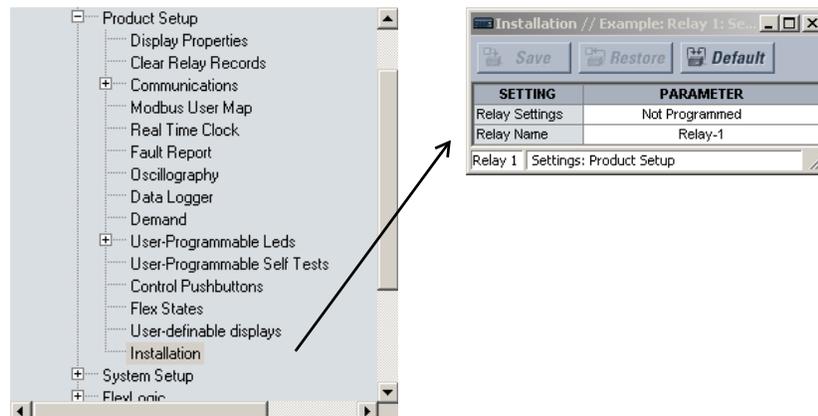
1. Change the Online Relay Settings from “Programmed” to “Not Programmed”. This will simultaneously disable the line differential at all terminals.

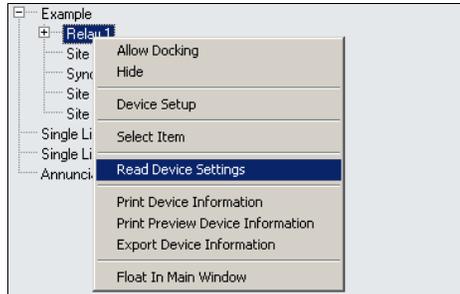
6. Upload existing relay settings from the relay by right-clicking on the device in the **Online Settings Window** as shown below.

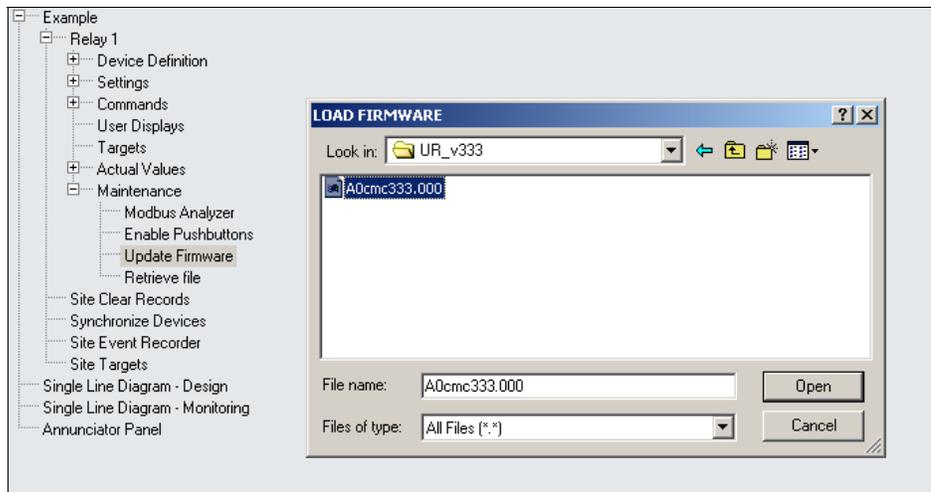
7. Select Update Firmware from the Maintenance menu. Choose the desired firmware file for upload to the relay.

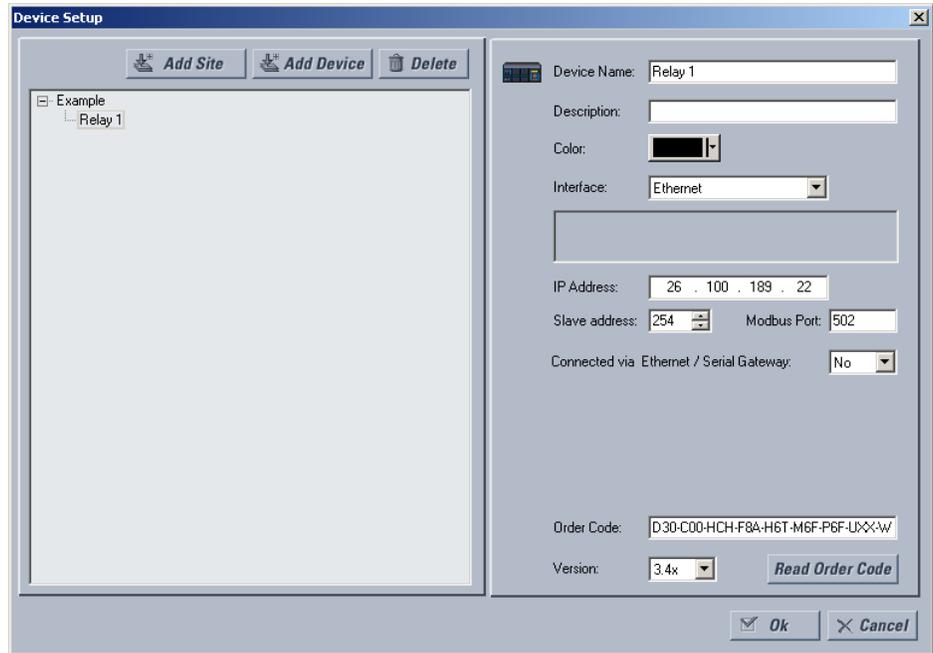
- From the **Device Setup** screen click the Read Order Code button. This will update the enerVista UR Setup device definition.

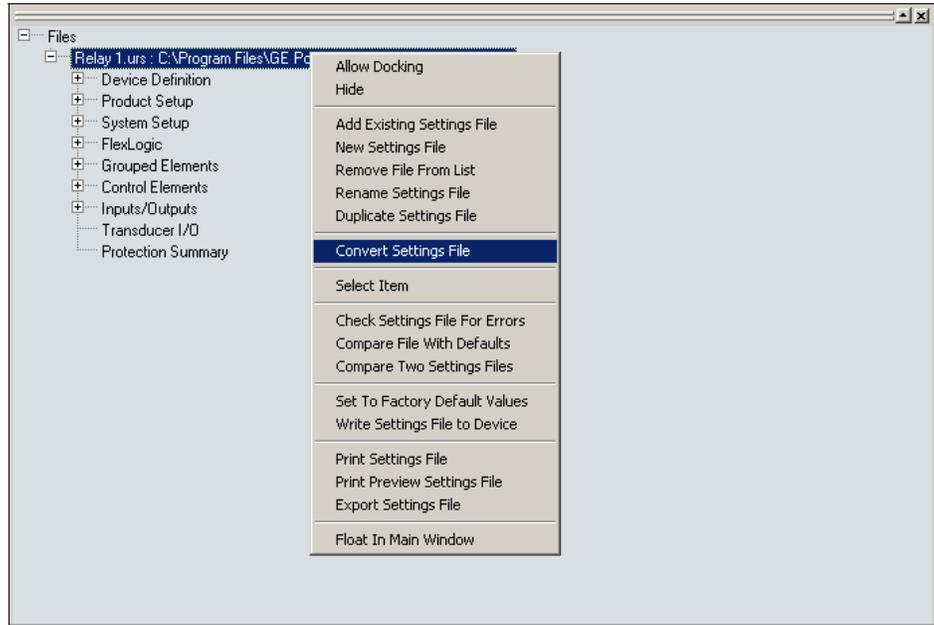
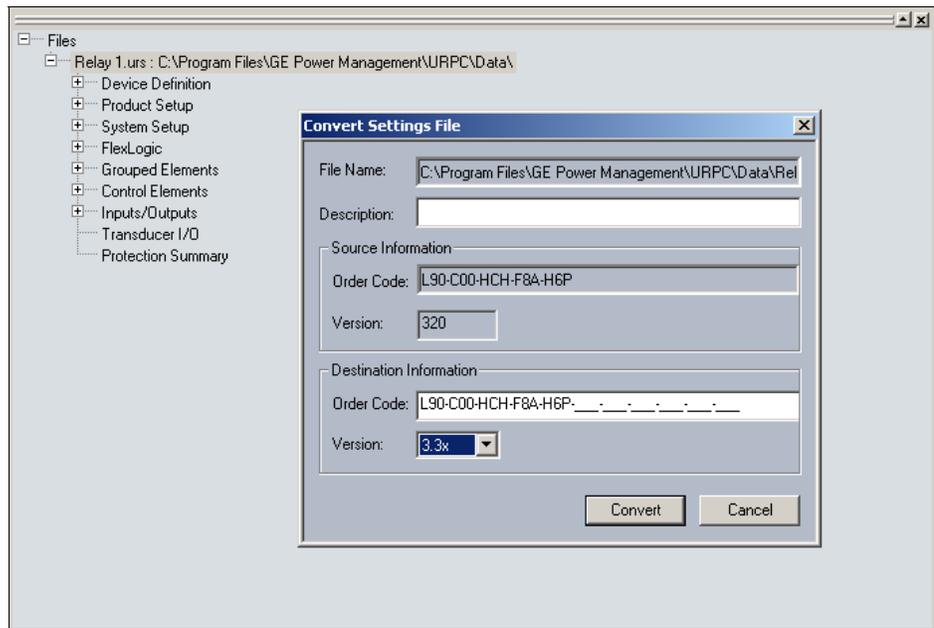
- If a minor firmware revision is being upgraded (second decimal place), the original setting file should be downloaded to the relay. If a major firmware revision is being upgraded (first decimal place), the setting file shall be converted to reflect the new firmware version and checked before downloading to the relay. To convert the setting file right-click on the offline setting file (this is the file created in step 5).

If the Convert Setting File item is displayed in grey then the required rights are not enabled in enerVista UR Setup. Go to User Management under the Security tab at the top menu bar and click on Enable Security. Next, go to Login User under the Security tab. Login as Administrator (default password URPC). Now, when right-clicking on the device, the Convert Setting File selection should be black.

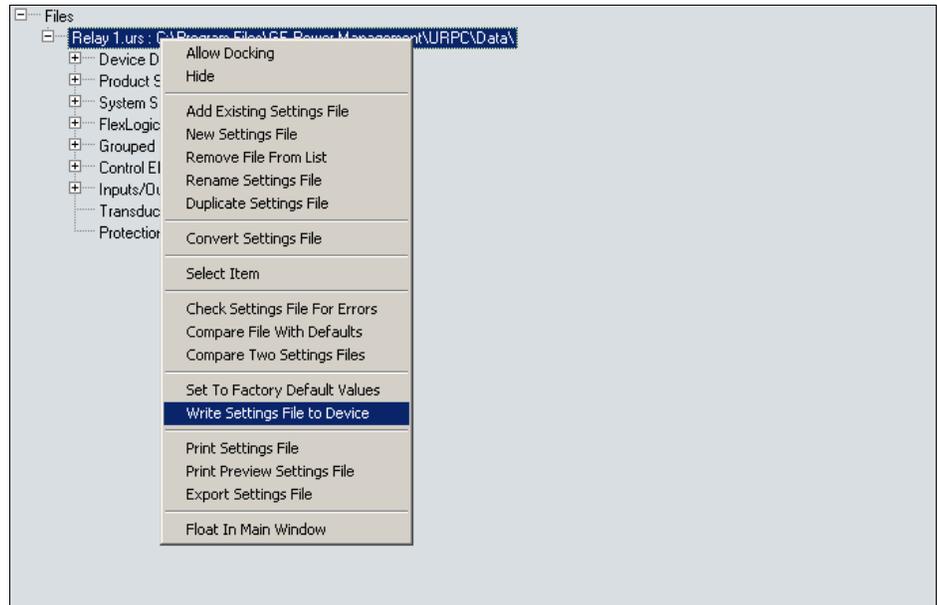
patibility may require changing new settings from their default to application-specific data; memory maps may be relocated, etc. After the converted setting file is reviewed and/or modified it should be uploaded into the relay. This can be done by right-clicking on the setting file and selecting Write Settings File to Device.

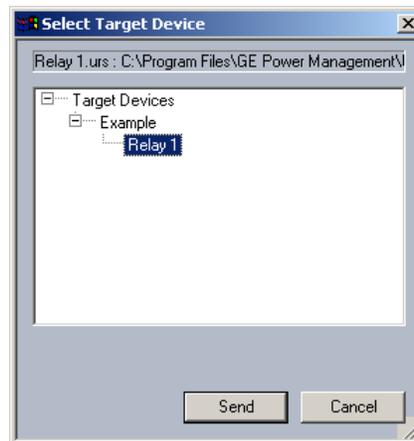
12. Select the device for upload and click **Send**.
